## Service Bulletin No. 26

**SUBJECT:** Swing out Windows

**AIRPLANES AFFECTED:** All Maule Models with swing out windows installed.

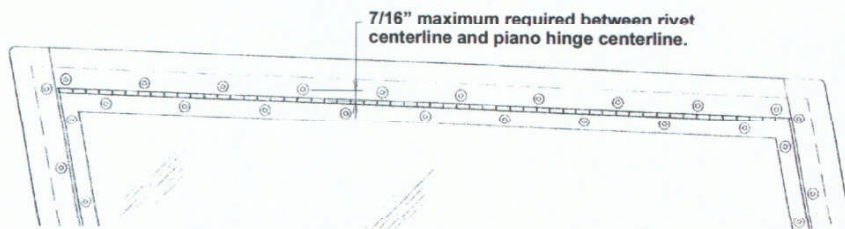
**BACKGROUND:** This Service Bulletin is prompted by a report from an owner that upon landing the swing out window fell out of the front door frame. After inspecting the installation it was determined that the holes for attaching rivets for securing the piano hinge to top door frame were being drilled too high (on center) through the window frame. The resultant loss of a window could cause a serious problem in flight.

1. On outboard side of front door and at top of swing out window, measure from centerline of piano hinge to center of rivets across top that secure piano hinge to doorframe and door skin. If dimension is within 7/16" maximum and there is a minimum of 8 rivets, assembly is acceptable. Go to Step 6 for further instructions.

2. **If measurement is over 7/16"**, remove top row of rivets (and 2 each rivets down both sides of door if skin is one piece) by drilling on rivet center using 1/8" drill. At lower end of door, under frame, drill 1/4, 1/4" in from edge and shake out rivet ends (optional).

3. Drill #30 holes and countersink 120°, equally between existing rivet holes at 3/8" dimension from centerline of piano hinge to rivet center. Note: If any rivets have been installed through piano hinge flange and doorframe, another rivet is not required in those rivet bays.

4. Install **SSC4-2S** blind countersink rivets to secure hinge flange to doorframe.
5. Reassemble door skin using **SSBL4-3S** rivets (with 3/8 dia. head) or **SSB4-3S** (with 1/4" dia. head). Matching the head size of existing door skin rivets may be preferred.

6. Examine the hinge flange to window frame rivet attachment. If space between rivets is greater than 3", drill #30 between and in line with the existing rivets that exceed the 3" spacing limit and install additional **SSB4-3S** rivets.
