MAULE AEROSPACE TECHNOLOGY, INC.

SERVICE BULLETIN #16

SUBJECT: Carburetor Heat Air Valve.

AIRPLANES AFFECTED: Maule airplanes manufactured before 1996 with Lycoming O-360-C1F, O-360-C4F, O-320-B4D, O-540-J1A5D, O-540-J3A5 and O-540-B4B5 engines.

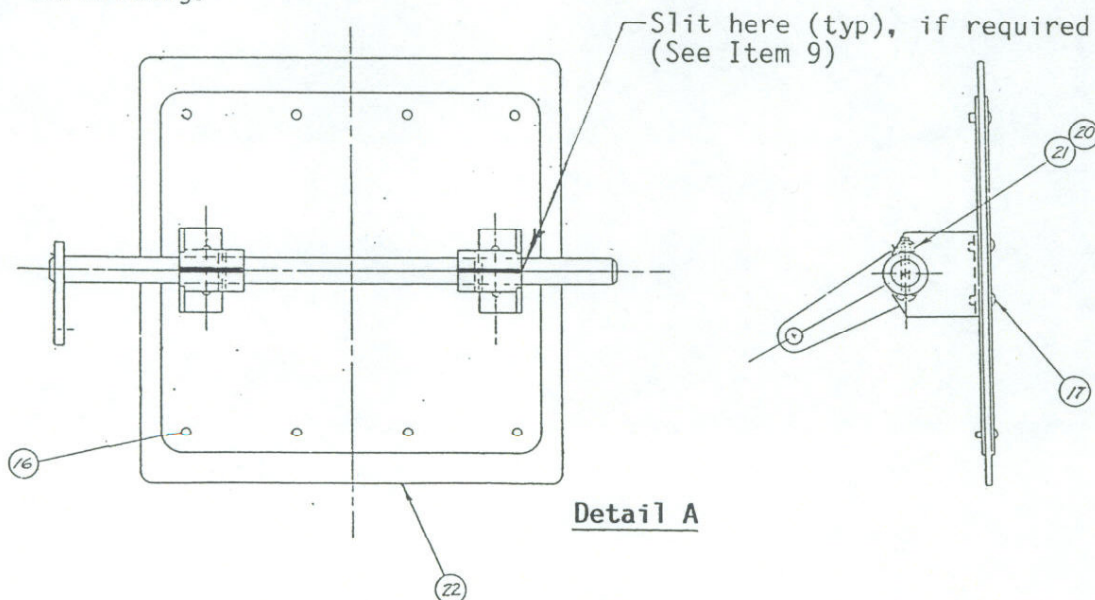
BACKGROUND: See attached Service Letter No. 56 regarding the reported failure of the valve rubber seal. Another incident was reported recently where a repair station made an inspection per Service Letter No. 56 and related that the seal appeared to be in good condition. However, a complete engine failure occurred 8 1/2 hours later because a strip broke off the seal and blocked the air to the carburetor. A forced landing ensued and airplane was totally damaged.

Also, we have received two reports of worn screws and elongated holes in shafts which caused valve to malfunction.

- 3) Remove the air box from the carburetor.
- 4) Remove the valve plate from the air box. This is accomplished by removing two AN526-8 screws and Nuts (Items 20 and 21, Detail A) which retain the valve plate to the shaft. Withdraw the shaft from the air box, then remove the valve plate.

- 9) Reinstall the valve in the air box and secure with the two (2) new MS27039-0814 screws and AN365-832 self-locking nuts. **CAUTION: Replacement of the screws and nuts regardless whether seal is changed or not is strongly recommended. If screw holes are elongated, repair as follows:**

- a. Slit top side of shaft brackets as shown in Detail "A" using a hacksaw blade (approximately 1/32" wide). Proceed with reinstalling valve and tighten securely. This will allow bracket to clamp shaft and prevent further wear.
