MAULE AEROSPACE TECHNOLOGY, INC.

**SERVICE BULLETIN NO. 17**

**SUBJECT:** Fuselage Tubes located near Forward Rudder Control Cables.

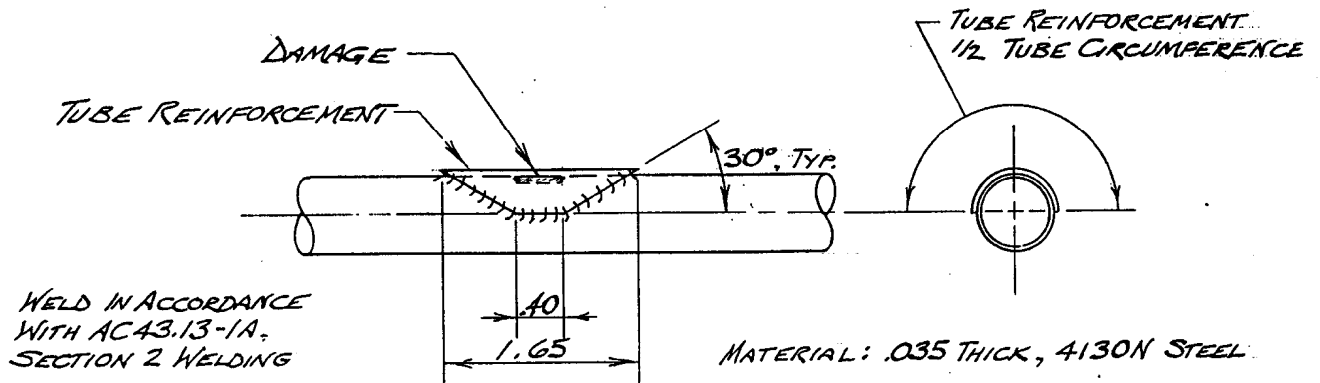
## Detail A

**PURPOSE:** Service Bulletin No. 14, attached for reference, is a mandatory requirement for inspection of left and right kick panels and forward rudder cables. There is also a possibility that these cables may have been forced against structural tubes #100 or #30 by kick panels causing damage to tubing. We have received two reports of cable rubbing cuts into tubing. This Service bulletin provides an inspection procedure and, if required, provides correction procedures.

1. Remove right and left forward kick panels. Left side will require removal of fuel valve handle.
2. Inspect fuselage structural tubes directly adjacent to rudder control cables. If there is no evidence of cable rubbing, no further action is required. Complete Compliance Record Sheet and return it to Maule Records.
3. If the cable has been in contact with the structure, carefully inspect the depth and width of the damage to the associated structural tube. This damage may be blended out with a fine file if the metal removed does not exceed a depth of .010 inch and a width along the tube of ¼ inch. If either of these dimensions is exceeded, the tube must be reinforced with a welded patch per Detail A, page 2 of this Bulletin.
