Service Bulletin No. 28

SUBJECT: (Gear- Driven) Flap Control Mechanism Inspection for the installation of the (Roller) Bushing located at the juncture of the safety-wired Connecting Link Spring Clips located at Turnbuckle Rod Eye Ends.

MAULE AEROSPACE TECHNOLOGY, INC.
Service Bulletin No. 28

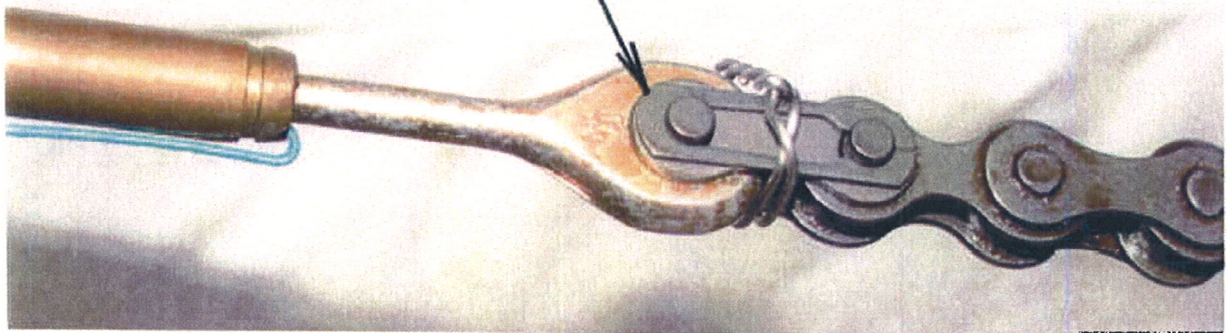
(Partial) Flap Control Mechanism Bottom Turnbuckle & Chain
(View Looking from Right Side of Aircraft)

Note: Proper Installation of Bushing in Rod Eye End. Observe no "daylight" gap.

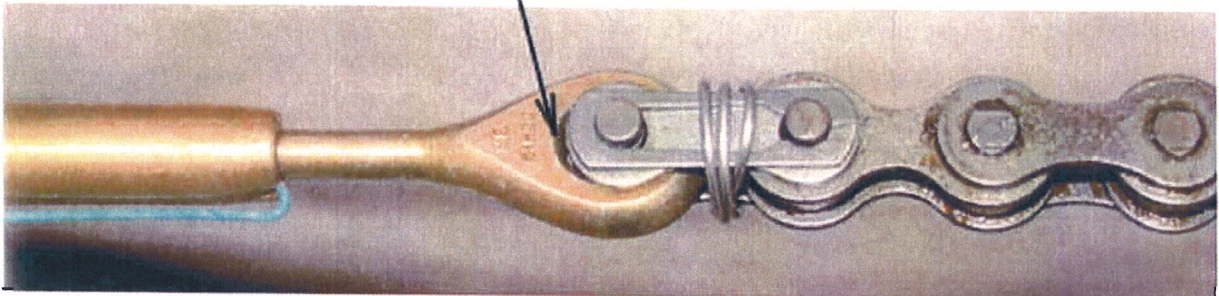
(Partial) Flap Control Mechanism Bottom Turnbuckle & Chain
(View Looking from Right Side of Aircraft)

BACKGROUND: Maule has discovered that the Turnbuckle Rod Eye End Bushings of the Flap Control Mechanism may have been inadvertently omitted on some of the above listed aircraft. There is the possibility of premature wear of the Roller Chain Connecting Pin(s) if Bushings are not installed. It is not possible for Maule to determine which of these Airplanes have Bushings missing.

Note: Bushing "missing" from Turnbuckle Rod Eye End. Observe "daylight" gap.

Note: Top Turnbuckle Treatment identical to bottom Turnbuckle.

1. Locate 2nd Access Zipper in Cabin Headliner aft of Dome Light Assembly.
2. Unzip (Flap Control Mechanism) Access Zipper and visually inspect both Turnbuckle Rod Eye Ends as per Maule Diagrams on Sheet 2.
3. If the (Roller) Bushing is found to be missing on either top or bottom, (or both) Rod Eye Ends, contact the factory at (229) 985-2045 to request a replacement(s) Turnbuckle Rod Eye End with Bushing Insert at no charge. Contact persons for part(s) will be Bryan Horne @ Ext. 239, or Barry Miller @ Ext. 223.
4. Following inspection and replacement of Rod Eye End with Bushing, if required (Ref. Note #3), fill out the accompanying Compliance Record Sheet (page 3) and return to Maule Aerospace Technology, Inc. Note in the Aircraft Logbook that Maule Service Bulletin No. 28 has been complied with.
