Maule Aircraft Corporation

SERVICE LETTER #17

MODELS AFFECTED: M-4C, M-4-210C & M-4-220C

SERIAL NUMBERS AFFECTED: 11C, 1066C, 1067C, 1071C, 1074C, 1075C, 1079C,
2012C, 2016C, 2018C - 2025C

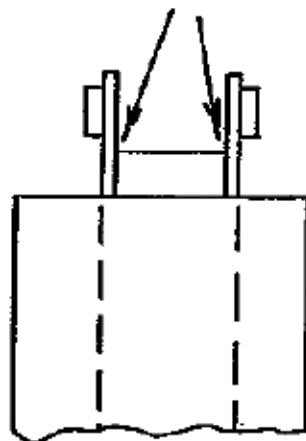
We have found a slight crack or die mark in the Flap and Aileron Hinge Brackets at the points as illustrated below. A through inspection should be made to assure that there are no cracks on your Brackets.

AILERON HINGE BRACKET

FLAP HINGE BRACKET

If cracks are found, they can be repaired in the following manner:

- (a) a crack $1/16$ inch or less may be filed out with a round 4 to 6 inch file, or
- (b) cracks $1/16$ inch or over should be half-arc or mig welded.

This inspection should be accomplished before your next flight and if cracks are found, the repairs should be made before flying. Enclosed you will find a card, please fill out and return.
